# HOUSES

A detailed analysis of the three stages in residential design will indicate what economic and cultural circumstances promoted their development. It will also show what construction differences gave all three a sense of individual character.

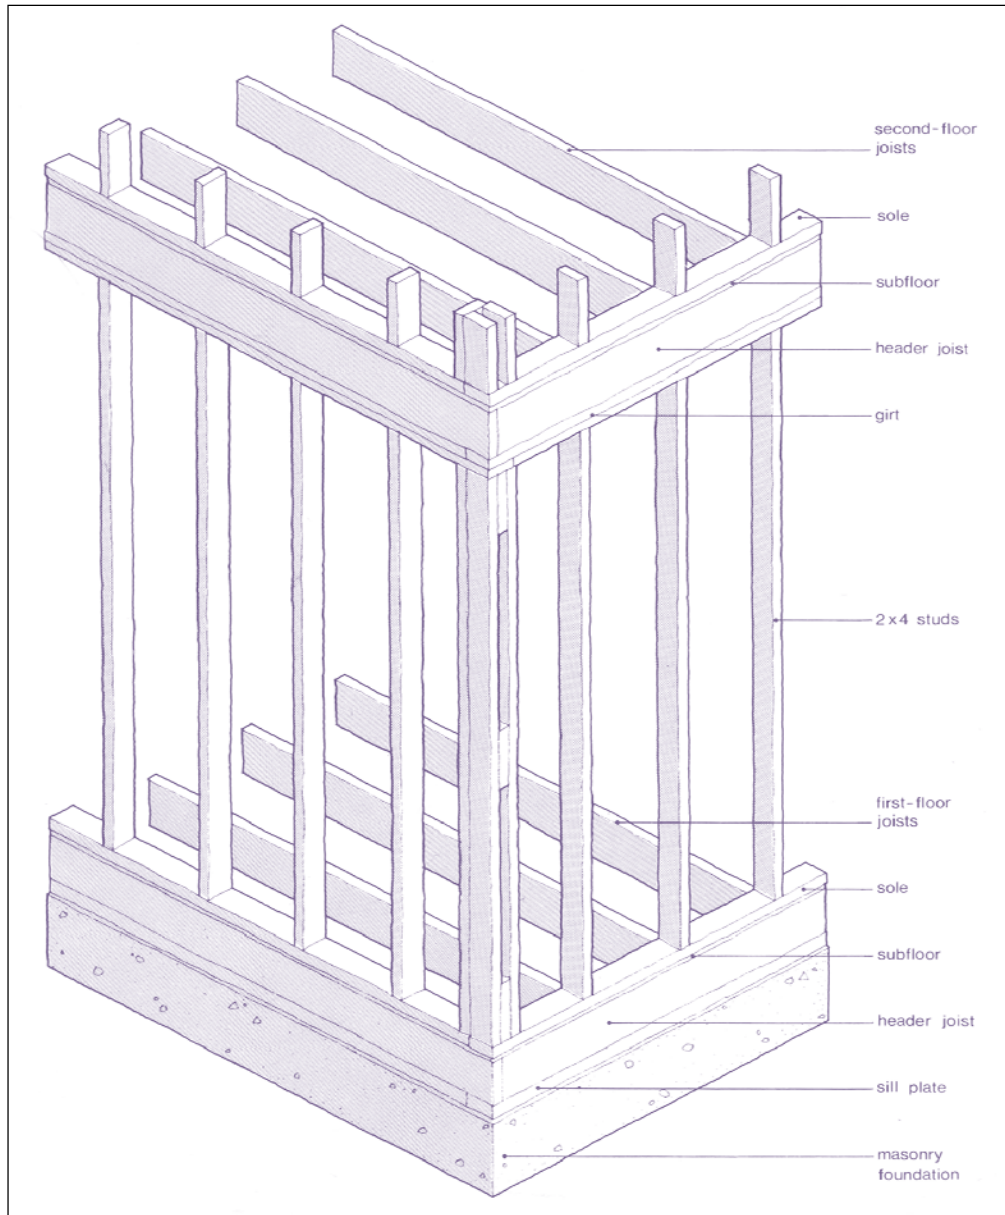
**Figure 19**  
Platform framing procedure. Each floor was built separately. The stud walls were assembled and arranged at each succeeding stage of the construction.

The platform framing procedure eliminated the need for long 40 x 80s (2" x 4"s) and also permitted construction in stages (Figure 19). Each stud wall, which extended only one storey, was pre-assembled as a unit at each succeeding stage of construction. The individual walls were fitted into prescribed vertical positions and secured to horizontal plates.
